CULTURAL LANDSCAPE REPORT
FOR THE SANDY HOOK
COASTAL DEFENSE BATTERIES
GATEWAY NATIONAL RECREATION AREA

CULTURAL LANDSCAPE REPORT FOR THE SANDY HOOK COASTAL DEFENSE BATTERIES

GATEWAY NATIONAL RECREATION AREA

FORT HANCOCK, NEW JERSEY

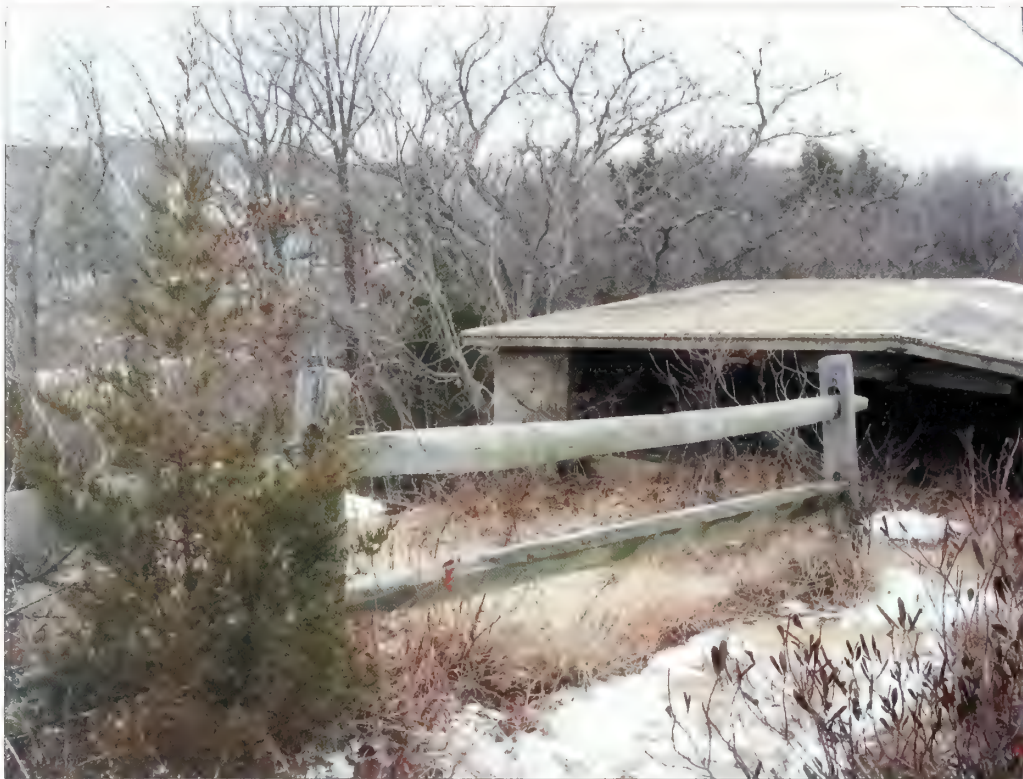
Figure 3.11. View looking northwest at Battery Engle (CRF Station Peck). The concrete coincidence range finder station (CRF) constructed on top of Battery Engle is located west of Battery Peck and features a low-pitched concrete roof. The structure appears in fair condition with some minor efflorescence visible on the roof (Olmsted Center, January 2009).

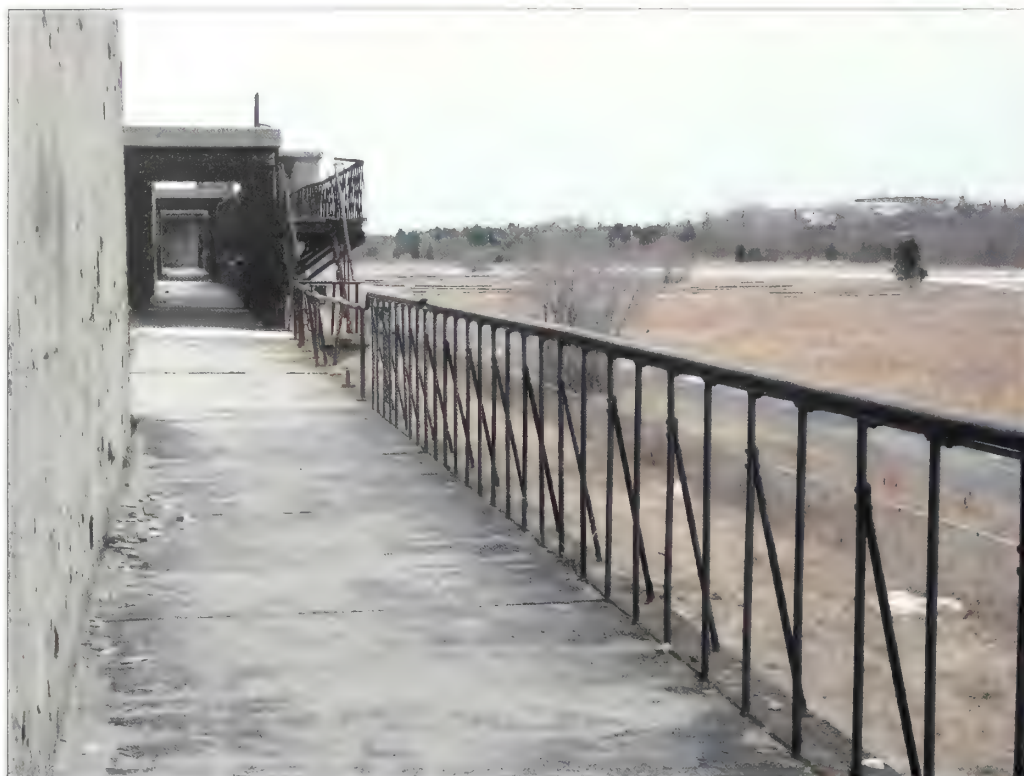
Figure 3.19. View looking south at existing guardrail, Nine Gun Battery. Both handrails and guardrails are present at Nine Gun Battery and are generally in good to fair condition (Olmsted Center, January 2009).

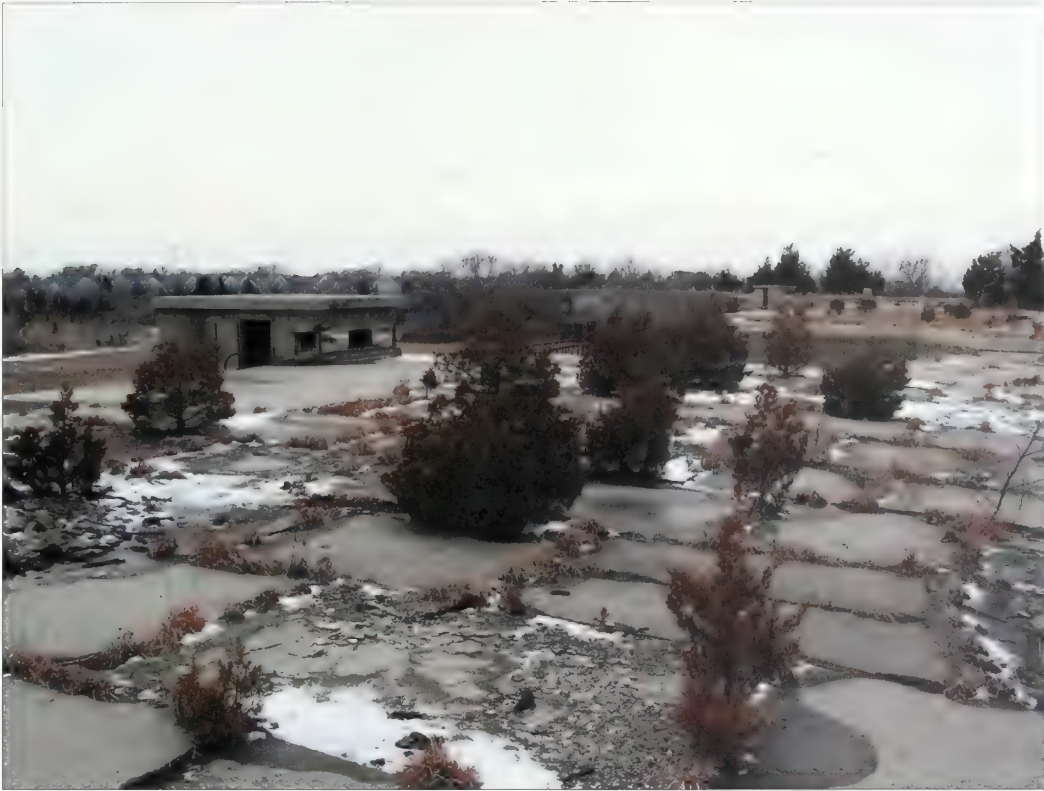
Figure 3.21. View looking west toward battery commander's station Bloomfield, Nine Gun Battery. In addition to growing on the engineered earthwork, eastern red cedars (*Juniperus virginiana*) have emerged in the cracks and cold joints of the battery's horizontal concrete surfaces (Olmsted Center, January 2009).

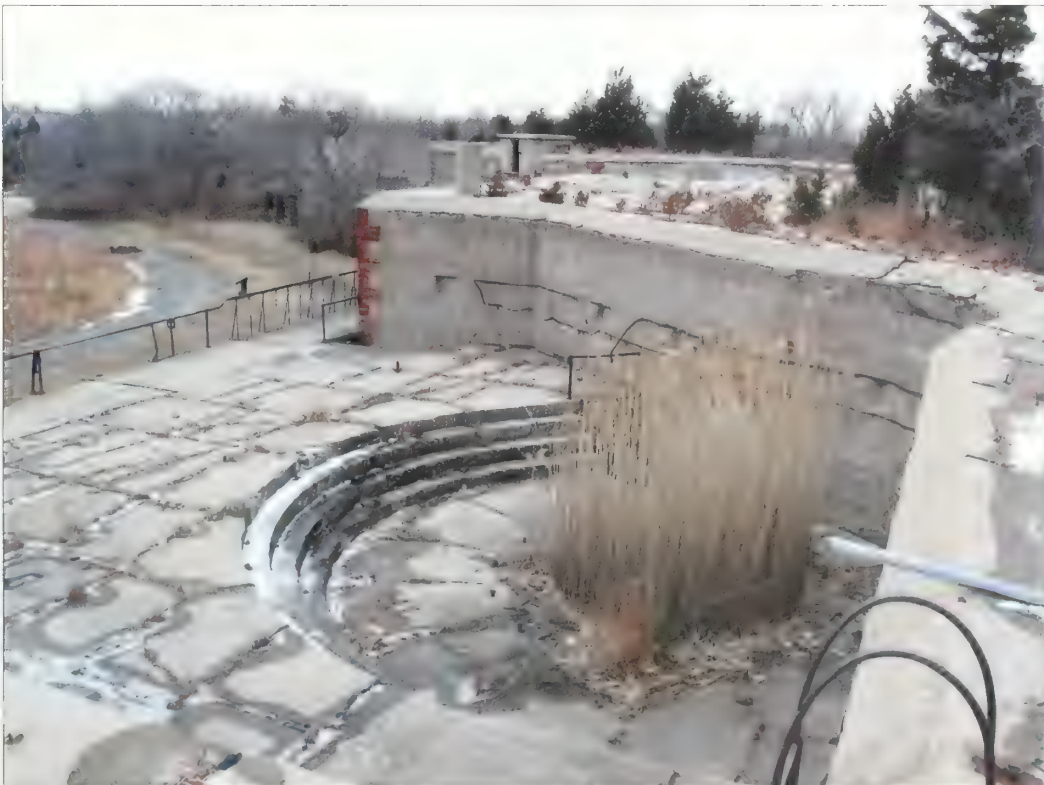
Figure 3.22. View looking west at emplacement #7, Nine Gun Battery. Phragmites (*Phragmites* sp.), also called common reed, is growing in the gun wells at emplacements #6, #7, and #9 (Olmsted Center, January 2009).

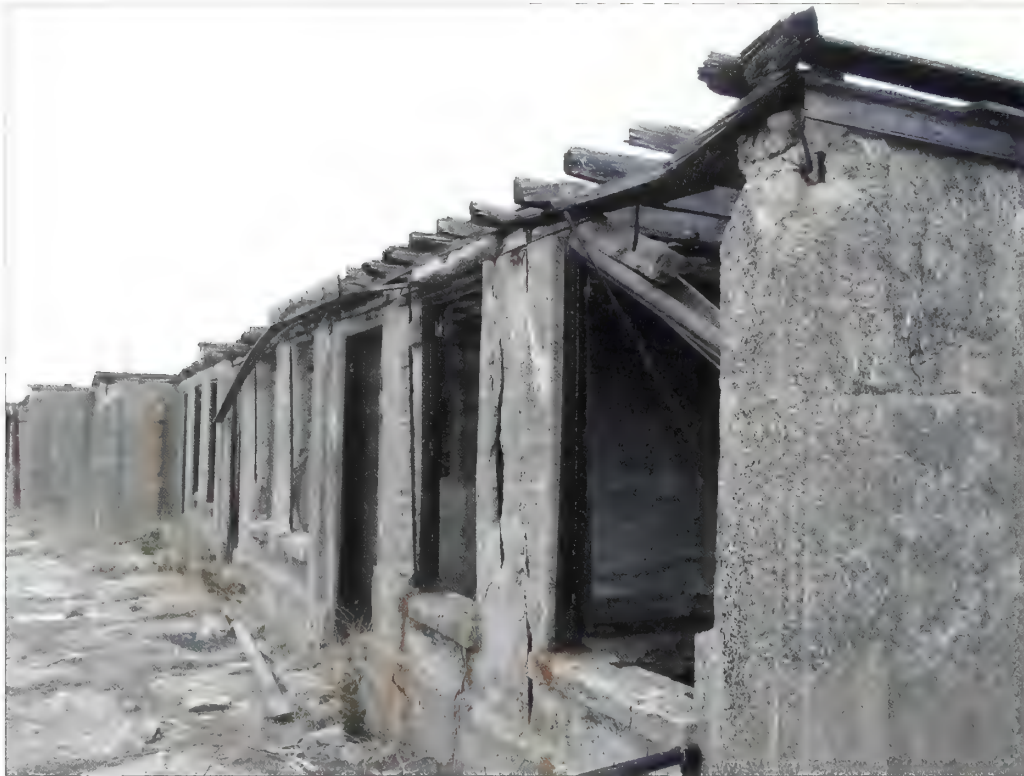
Figure 3.27. Fire control stations, Battery Potter. On the terreplein, two groups of deteriorating concrete structures are located west of the former gun emplacements. The structures served as fire control stations and feature large openings in their east elevations to provide views to the Atlantic Ocean (Olmsted Center, January 2009).

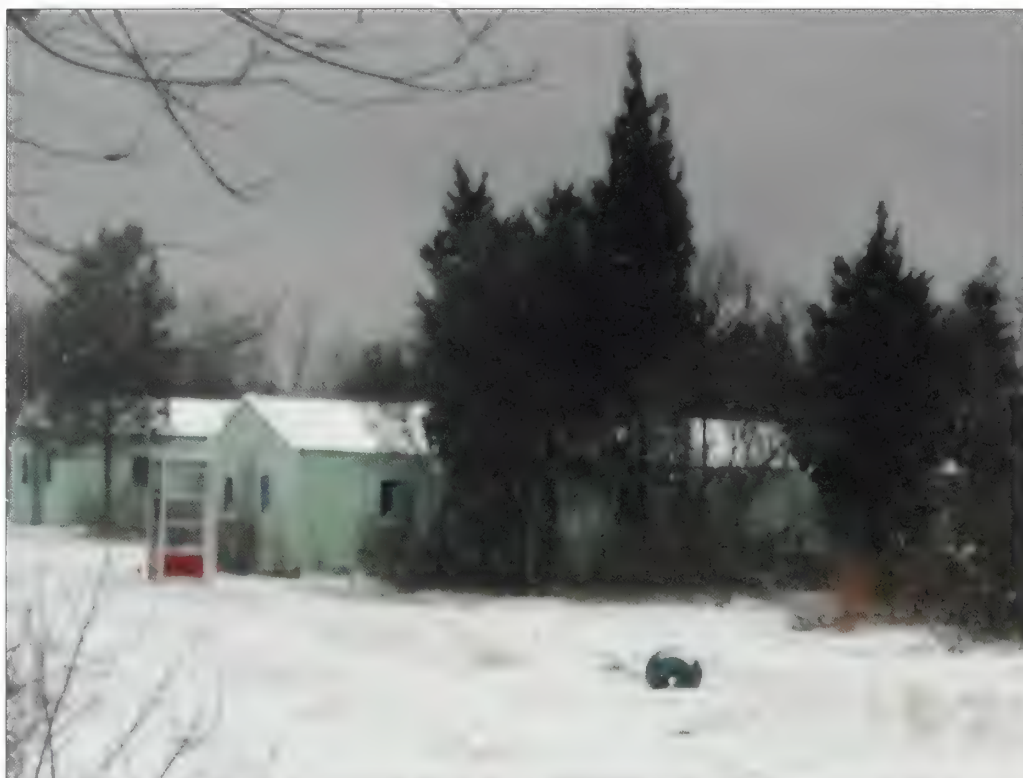
Figure 3.63. View looking northwest at the Ready Barracks, NIKÉ radar site. Pedestrian-scale lights line both walks from the control areas to the Ready Barracks. The lights are in good to fair condition with the exception of one light pole which is knocked over (Olmsted Center, January 2009).

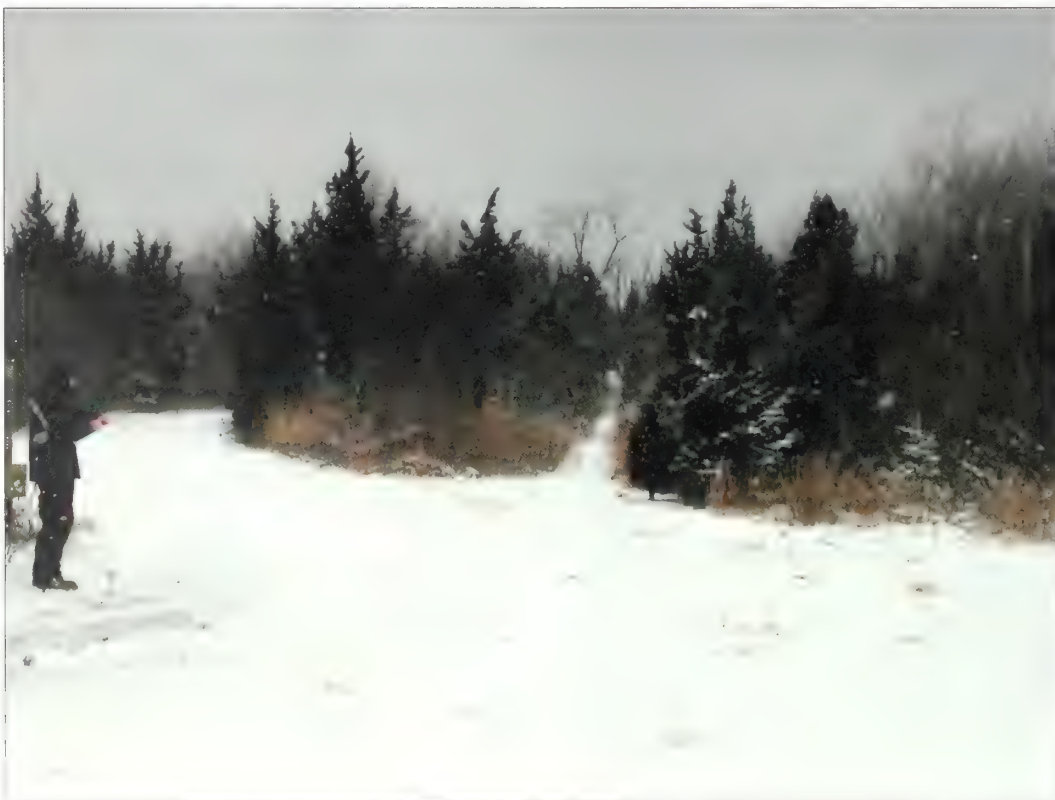
Figure 4.17. View looking northwest at pedestrian walkway, Control Area #1, NIKE radar site. The concrete walkways connecting the control areas and Ready Barracks are presently extant and in fair condition. Some portions of the sidewalks are being covered by encroaching woody vegetation (Olmsted Center, January 2009).

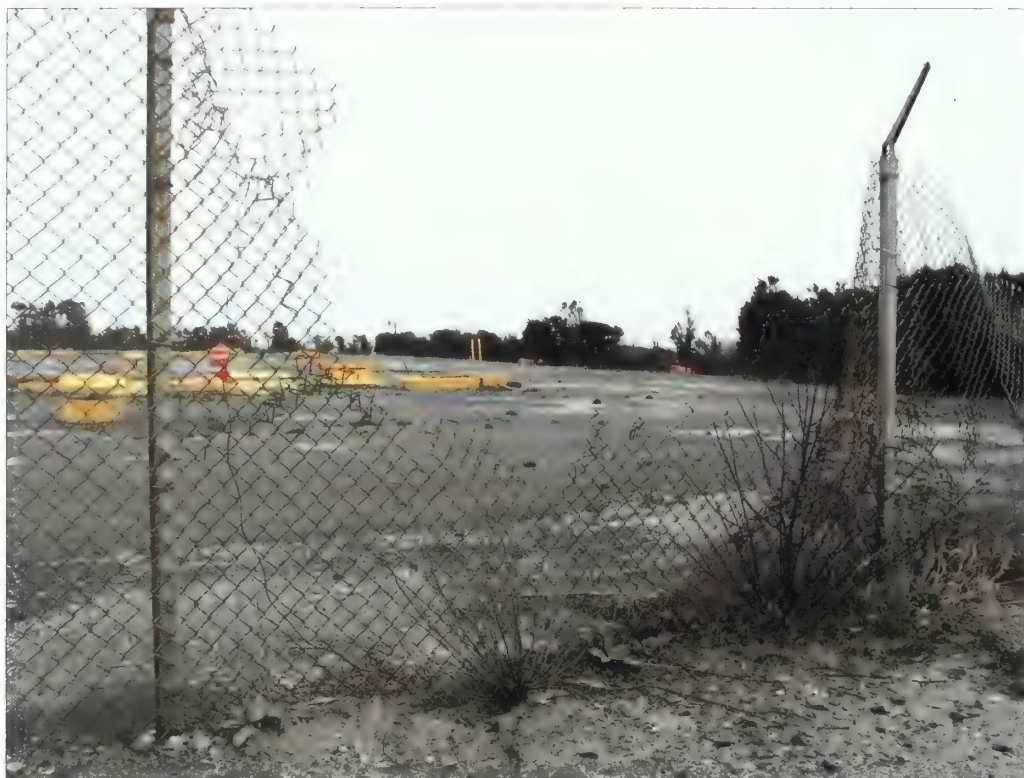
Figure 4.28. View looking southeast across Missile Magazines, NIKE launch site. The Army installed an inner security fence around the Missile Magazines as a component of the launch site's security upgrades to use Hercules missiles fitted with nuclear warheads. The inner fence is presently extant with chain-link sections attached to H-shaped posts and is in fair to poor condition (Olmsted Center, April 2008).

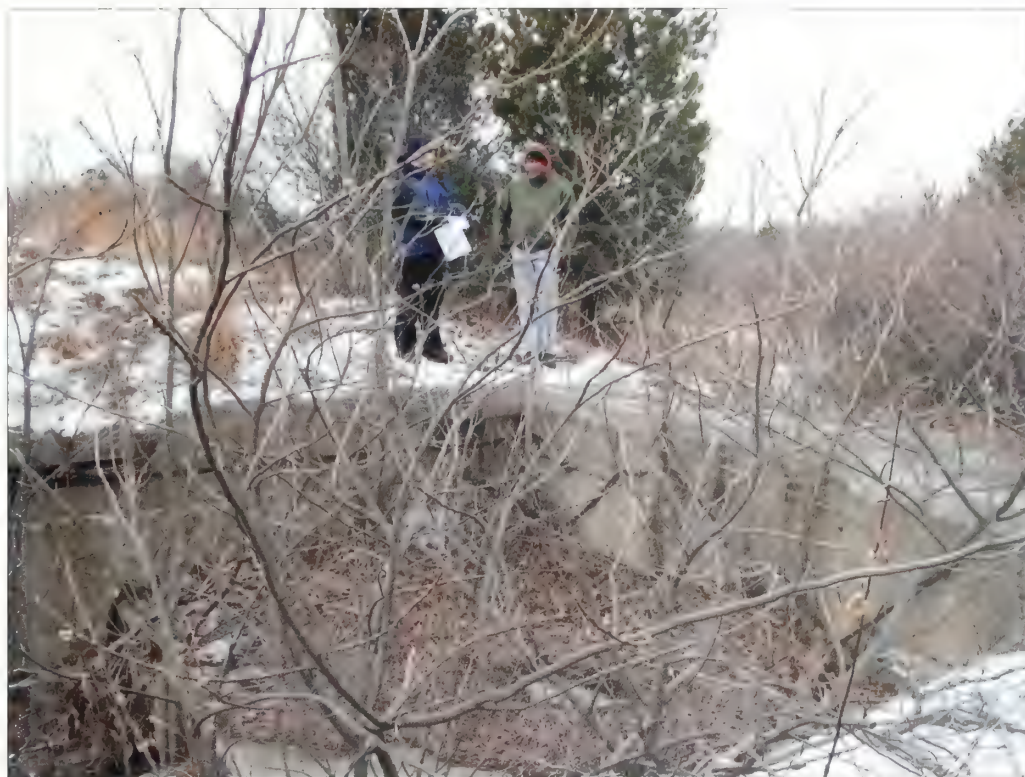
Figure 5.9. View looking northwest across gun platform #4, Battery Urmston. Low and flat areas like this gun platform have accumulated soil, leaf litter, and moisture. These conditions have resulted in the growth of woody vegetation that should be removed from the structure (Olmsted Center, January 2009).

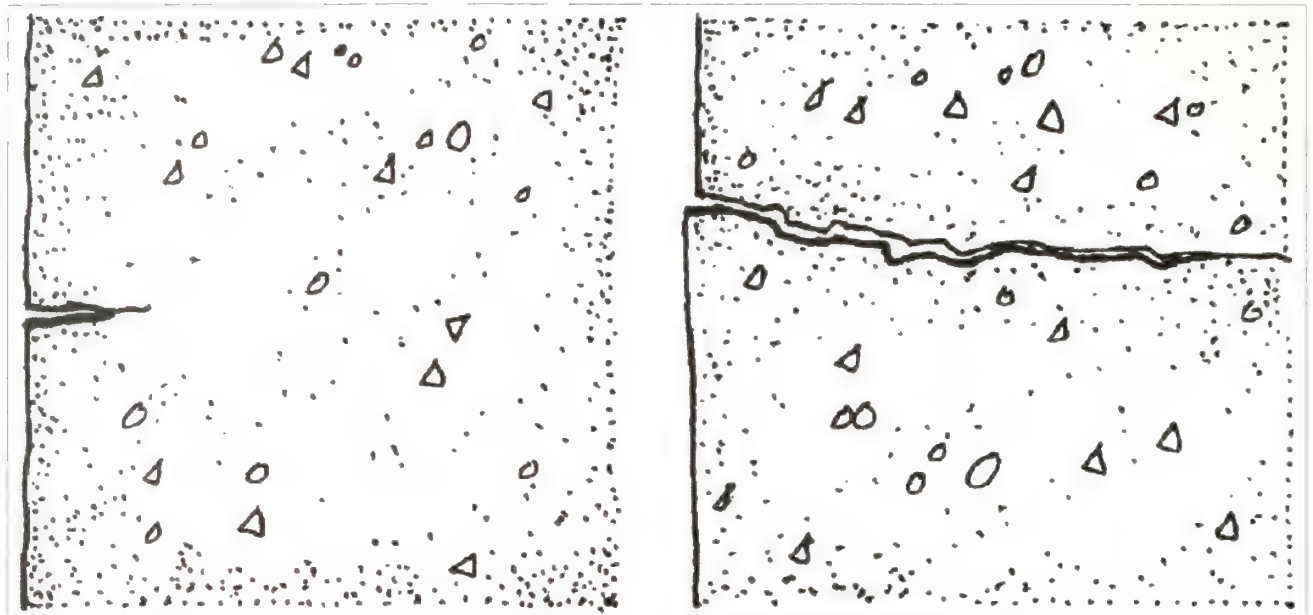
Figure 5.19. Typical concrete cracks. The image on the left illustrates a small, surface crack that can be repaired by grouting and sealing. The image on the right illustrates a large, structural crack that will require extensive repairs. Consultation with a structural engineer is recommended to determine a preferred method of repair (Freeman et al., *Seacoast Fortifications Preservation Manual*, 147).

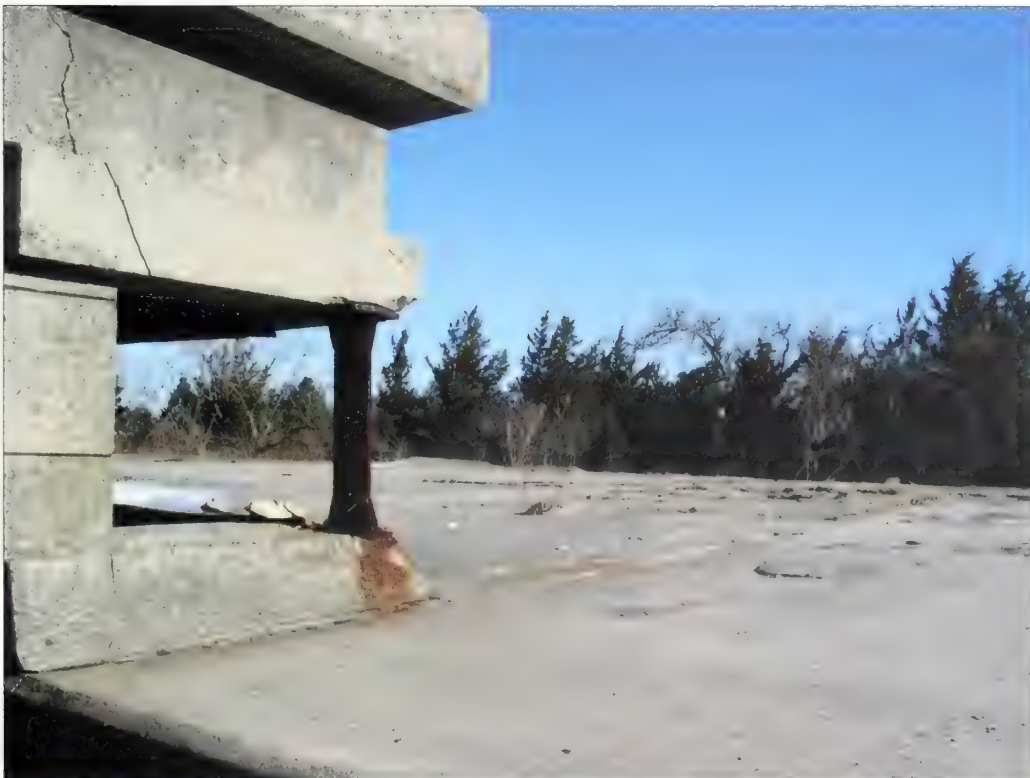
Figure 5.68. Blocked view northeastward from the battery commander's station at Battery Granger. Blocked downrange views to the water makes it difficult for park visitors to understand the historic operation of these coastal defense sites. Note corrosion of ferrous metal building features (Olmsted Center, January 2009).

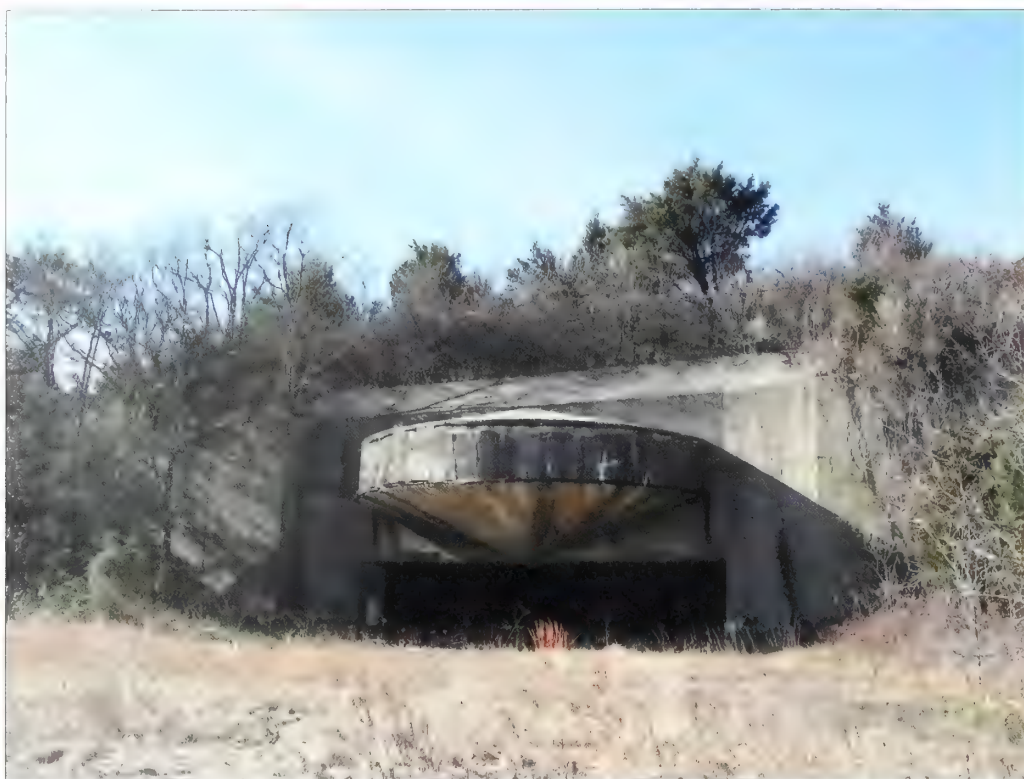
Figure 5.85. View looking southwest at north gun emplacement, Battery Kingman. Although visitors are warned of the hazards of accessing the summit of these batteries, existing chain-link fencing located above the concrete casemate canopies should be maintained for added safety at both Battery Kingman and Battery Mills (Olmsted Center, January 2009).

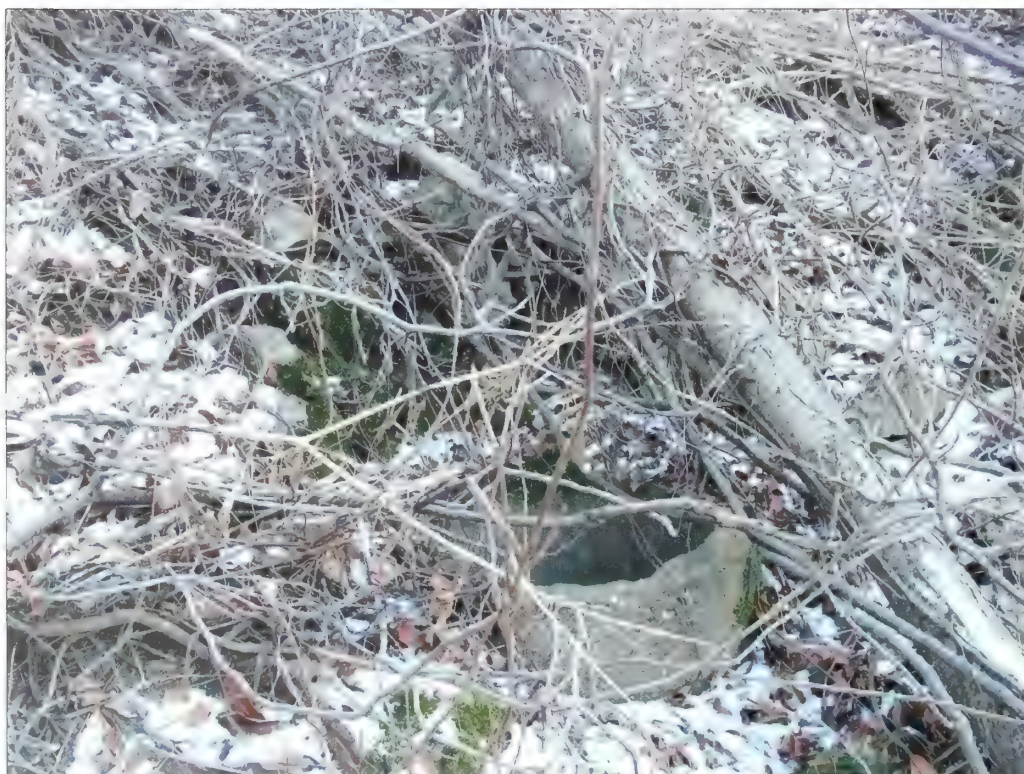
Figure 5.86. Concrete pipe on north slope of Battery Kingman. The concrete pipe should be capped to prevent possible injury and reduce water entering into or around the underground structures (Olmsted Center, January 2009).
